# Laurens County Tornado of 13 January 2005

## Survey and Assessment of Storm Damage

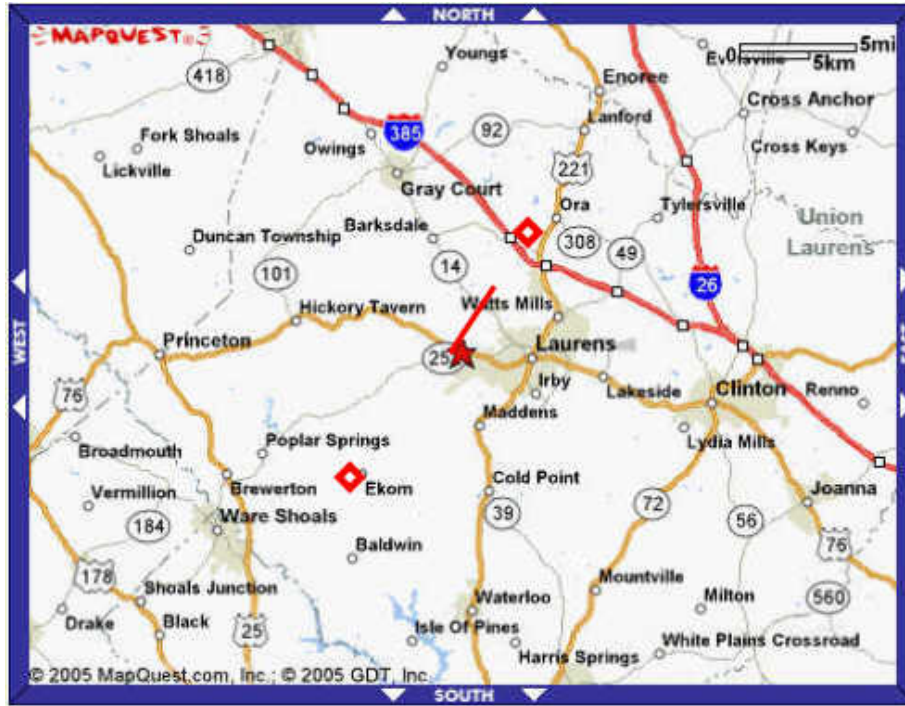
Fig. 2. Diamond markers and straight line indicate locations of tornado damage. The storm traveled from southwest to northeast. The damage at each mark is discussed in the text.

The first known damage caused by the storm occurred in the Ekom community, approximately 10 miles southwest of Laurens, where two mobile homes were damaged. Based on the radar location of the mesocyclone and TVS, this event occurred at approximately 713 pm EST. Damage along the storm's track was not reported or observed again until a point was reached one quarter to one half mile south of U.S. 76 near Laurens High School. On the south side of U.S. 76, a number of trees were blown down and others were snapped in half. Small sheds were destroyed and a portion of a roof was removed from a house.

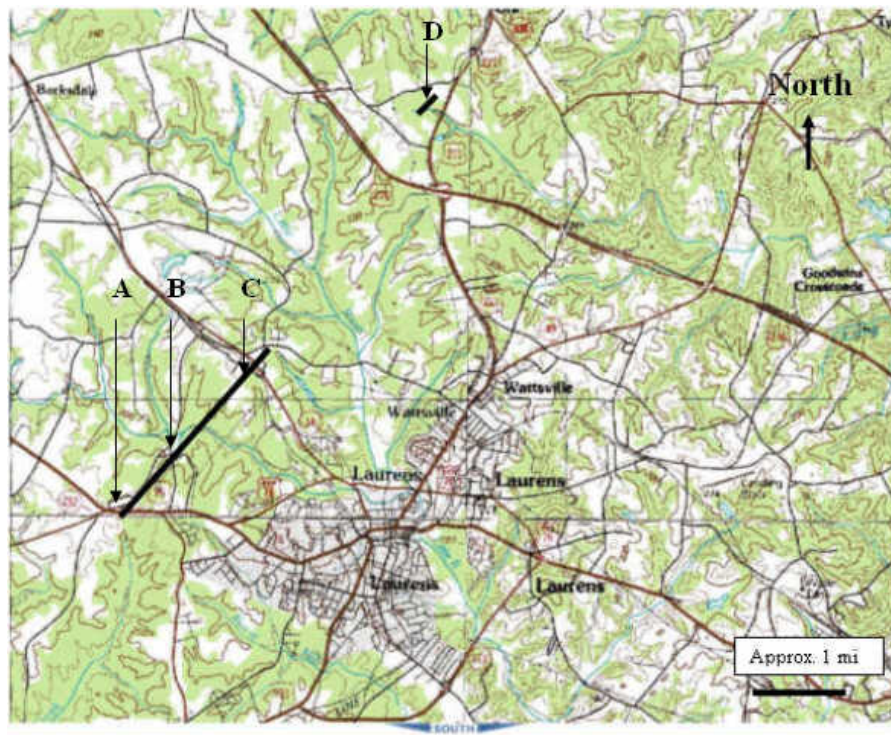
Fig. 3. Map of the Laurens vicinity showing tornado track from near Laurens High School northeast to just north of S.C. 14. The high school is near the tip of arrow A. Damage also occurred at TNT Logistics near the tip of arrow D. The damage near Ekom is not depicted on this map.

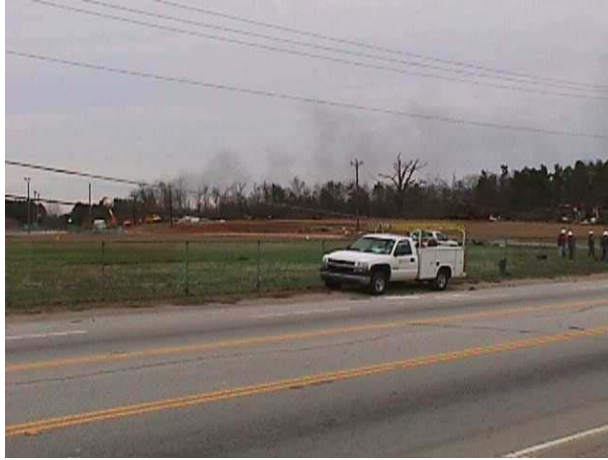
Fig. 5. Picture taken from U.S. 76 in front of Laurens High School. View toward the northeast where smoke from the TNT Logistics fire is visible. NWS photograph.

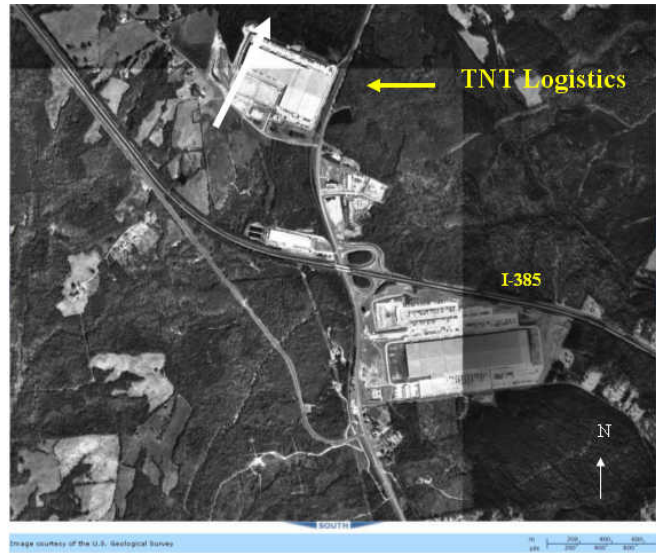
Fig. 16. Aerial view of the TNT Logistics area. White arrow identifies approximate track and direction of storm motion. (Image courtesy USGS and TerraServer-USA)

The damage to the TNT Logistics facility and nearby trees is determined to be F1 tornado damage. The WSR-88D TVS had weakened at this point, but it reappeared when the storm was approaching Enoree in extreme southern Spartanburg County. No evidence of wind damage has been found along the remainder of the storm’s track through Laurens County into Spartanburg County. However, reports were received at the WFO shortly
